# Atlantic Richfield Company

April 18, 2017

**RE: Leviathan Mine Site: Revised Update on Limited Access Season Site Conditions  
April 5 - 12, 2017**

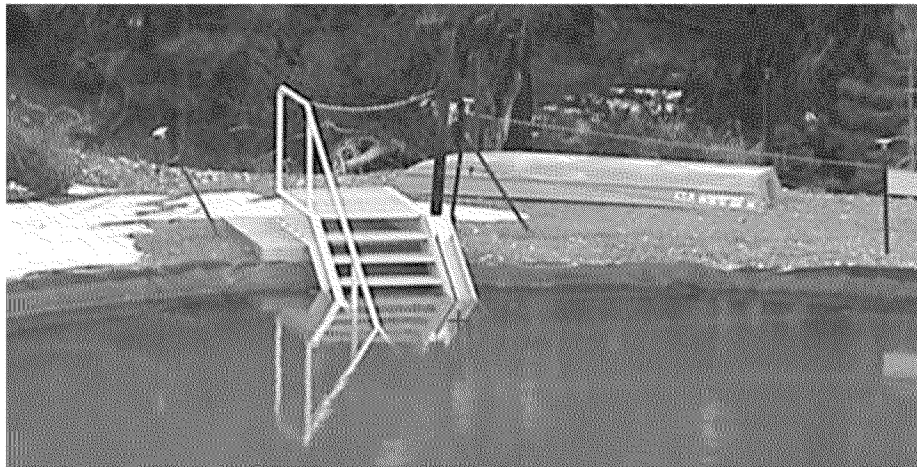
Atlantic Richfield personnel continuously monitor water levels in the ASB ponds using the remote camera. On April 5, 2017, personnel observed that water levels in ASB-Pond 4 were rising above typical levels for that pond. This was attributed either to a blockage at the effluent launder or influent flows into the ASB that exceeded the hydraulic capacity of effluent piping, or both. As of April 5, 2017, ASB-Pond 4 still had approximately 75,000 gallons of storage available.

April 6, 2017: ASB-Pond 4 before piping modifications and siphoning.

Copper Environmental personnel accessed the ASB on April 6, 2017. Personnel cleared debris from the Pond 4 effluent launder, increased the diameter of the outlet piping from 1-inch to 2-inch, and disconnected the 1-inch in-line flow meter. They also pumped approximately 21,000 gallons of treated water out of ASB-Pond 4 to the aeration channel to lower the pond water level. Treated effluent continued to discharge from ASB-Pond 4 to the aeration channel following these modifications.

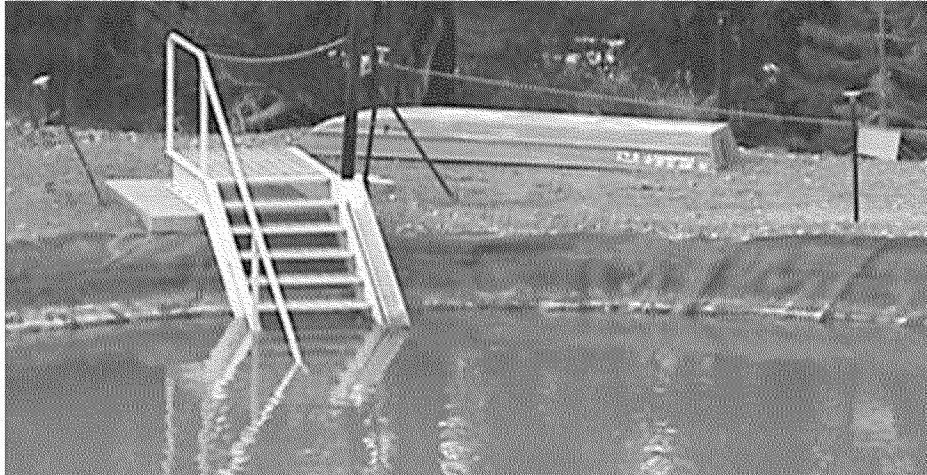
April 6, 2017: ASB-Pond 4 after piping modifications and siphoning.

The result of these efforts is increased effluent flow out of the bioreactor – to better match the influent rate (measured at 25 gpm on April 5, 2017 and 28 gpm on April 10, 2017) – and a substantially lowered Pond 4 water level. These efforts prevented any uncontrolled overflow from Pond 4 and overtopping of the Pond 4 berm. Atlantic Richfield does not anticipate any erosion or the need for other contingencies to prevent an overflow at the present time.

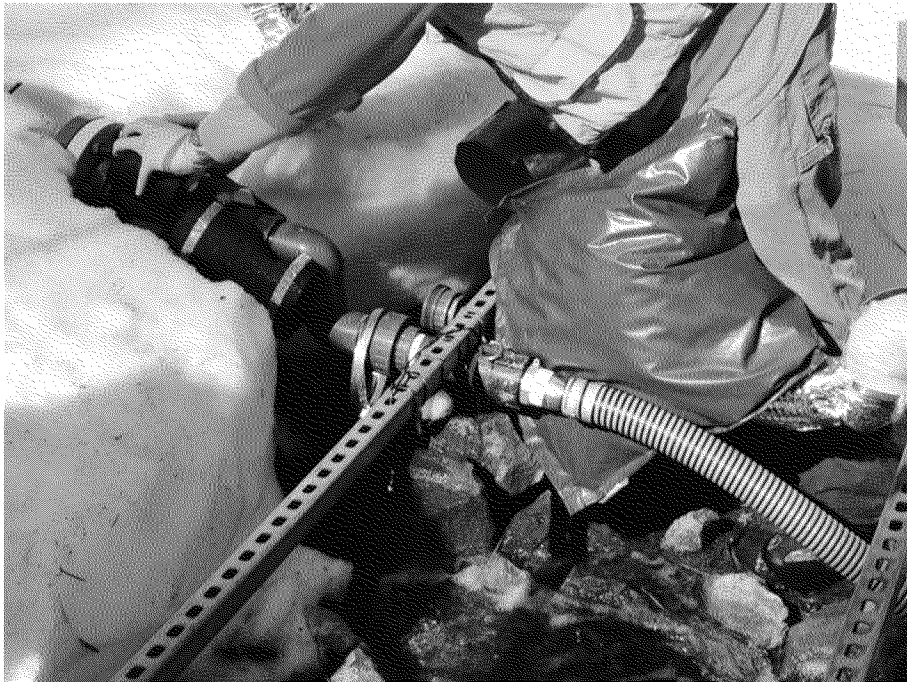
April 6, 2016: Replacement 2-inch effluent line discharging to aeration channel.

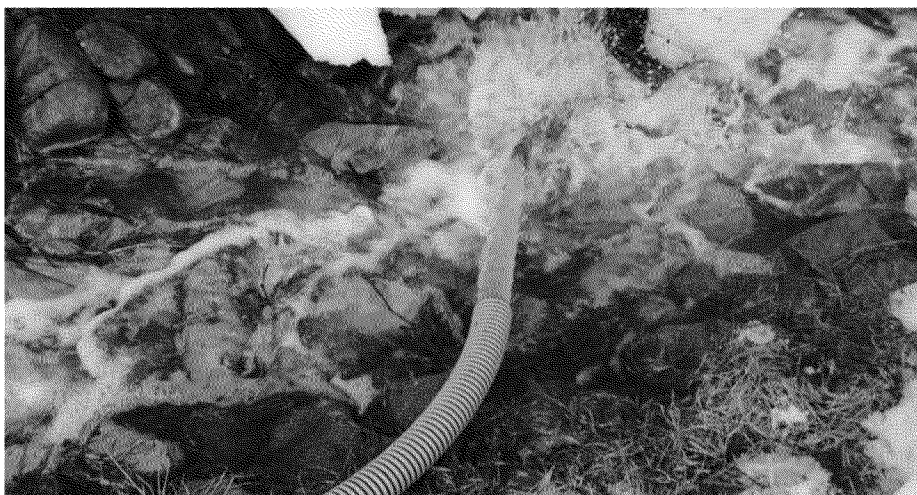
April 6, 2017: ASB-Pond 4 treated effluent discharged through 2" pipe to aeration channel.

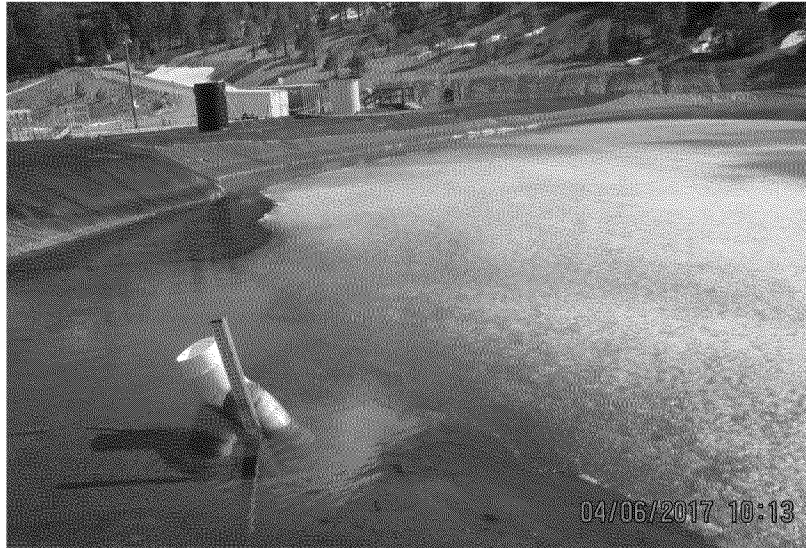
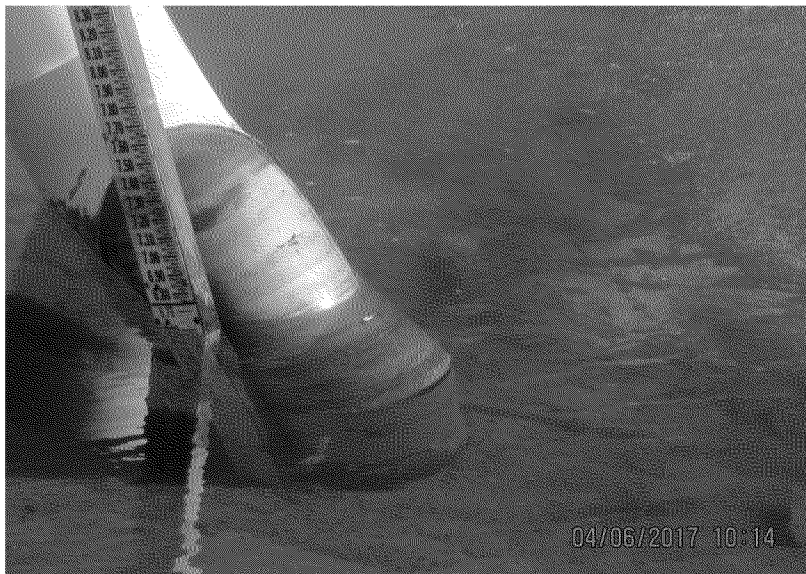
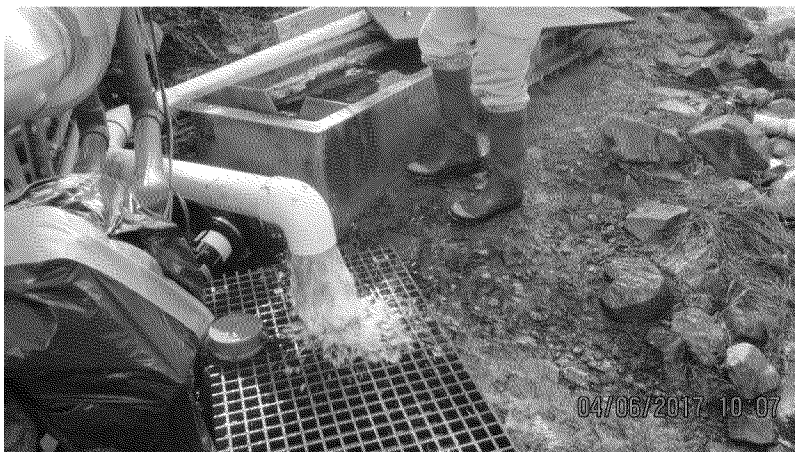
On April 6, 2017, at approximately 3:30 PM PDT, Atlantic Richfield received word from the LRWQCB that a connection on the overflow riser pipe assembly in Pond 4 (near the HDS

treatment building) had separated a few inches below the water line, and as a result, water was discharging through the overflow pipe to Leviathan Creek. Photographs sent by the LRWQCB are shown below:

It appeared from the photos that the separation may have resulted from ice pushing against the riser pipe assembly. Atlantic Richfield does not normally have personnel at the site at this time of year, and the pipe separation was not the result of any human-caused activity. It also appeared that there were only a few inches of standing water in Pond 4 above the pipe separation, and the section of pipe below the separation was intact. According to Doug Carey, LRWQCB Board crews who were at the site earlier in the week did not observe any discharge from the Pond 4 overflow pipe, so we assume the separation occurred sometime between April 4 and April 6, 2017. pH measurements from EPA's data sonde in Leviathan Creek at 4L did not suggest that the resulting discharge from Pond 4 was having any significant effect on surface water quality during this time:

On April 7, 2017, Copper Environmental field personnel entered the site, despite poor weather conditions (sleet and snow). Personnel waded into Pond 4 and re-set the overflow riser pipe assembly into the lower pipe receiver as best they could. Personnel also placed temporary sandbags around the riser pipe assembly in an attempt to stabilize the piping. Discharge from Pond 4 through the discharge pipe increased briefly while the riser pipe assembly was being removed and then reset. After resetting the assembly, the discharge rate decreased, but flow was not completely stopped. As a result, Copper began formulating plans for additional, more permanent repairs to the riser pipe assembly to be made the following week.

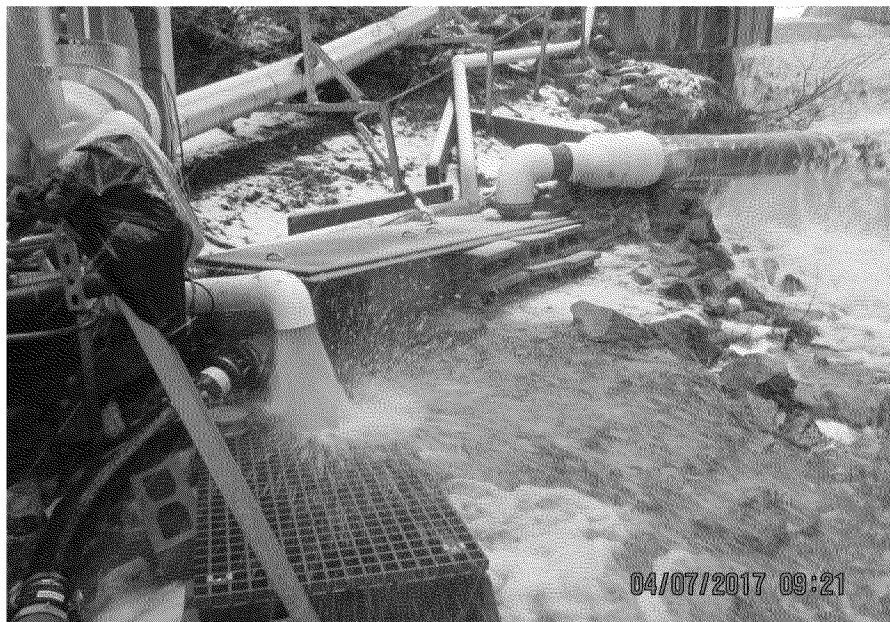
April 7, 2017: Overflow pipe discharge while Pond 4 riser pipe assembly was being removed and re-set.

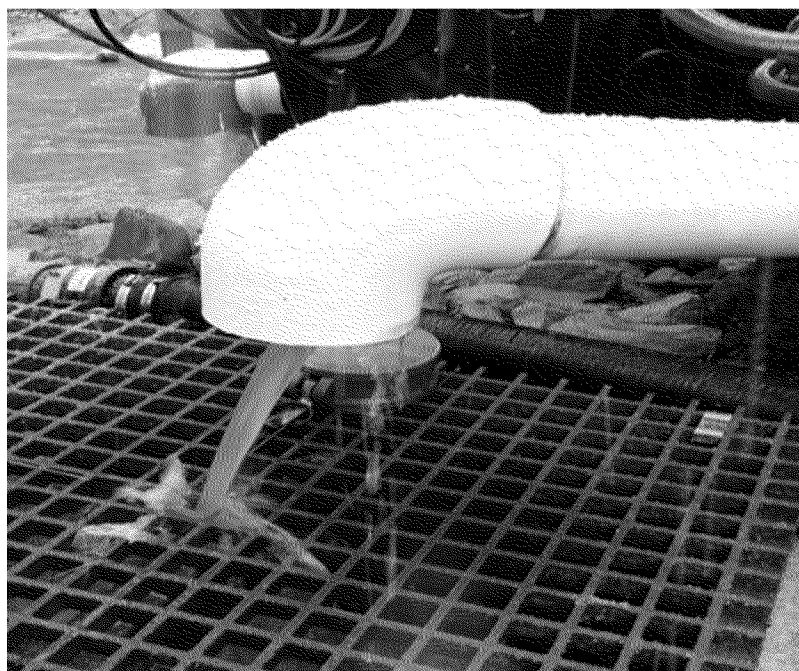
April 7, 2017: Overflow pipe discharge after re-setting of the Pond 4 riser pipe assembly.

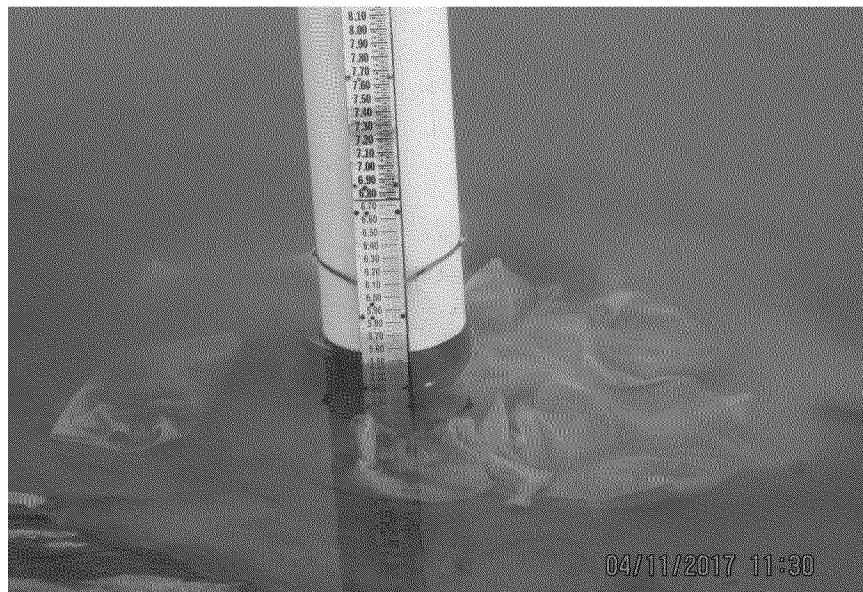
April 11, 2017: Repaired riser pipe assembly. Pond water level at 5.50'.

On April 11, 2017, crews returned to the site to complete more permanent repairs to the Pond 4 riser pipe assembly. A new stand pipe was inserted into the lower pipe receiver and better stabilized with appropriate fittings and clamps. The pond water level staff gage was also re-set, and some of the sand bags were removed. Following these additional repairs, no flow was observed from the discharge pipe outlet. Photographs showing conditions following these additional repairs are provided below:

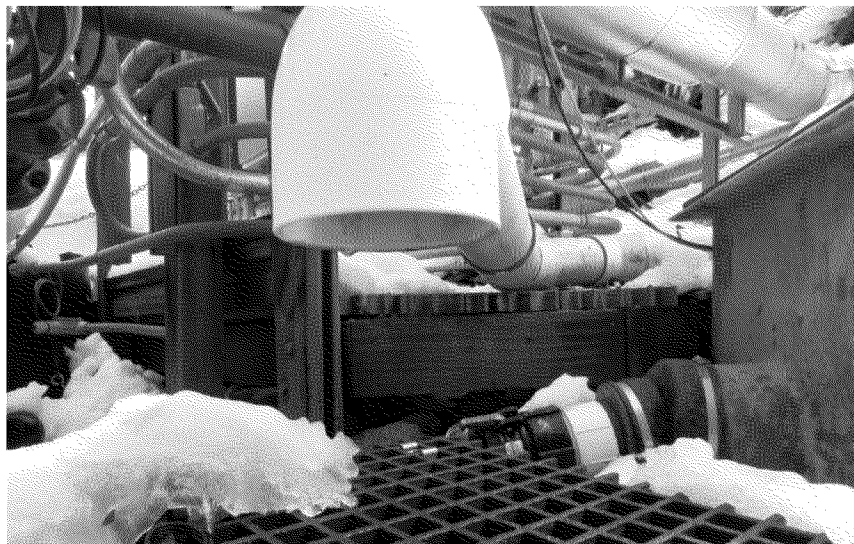
April 11, 2017: Discharge pipe outlet following repairs to riser pipe assembly.
